# **A-Board Insurance Claim Analysis**

Prepared by: Robert J. Abend, PE

July 16, 2014

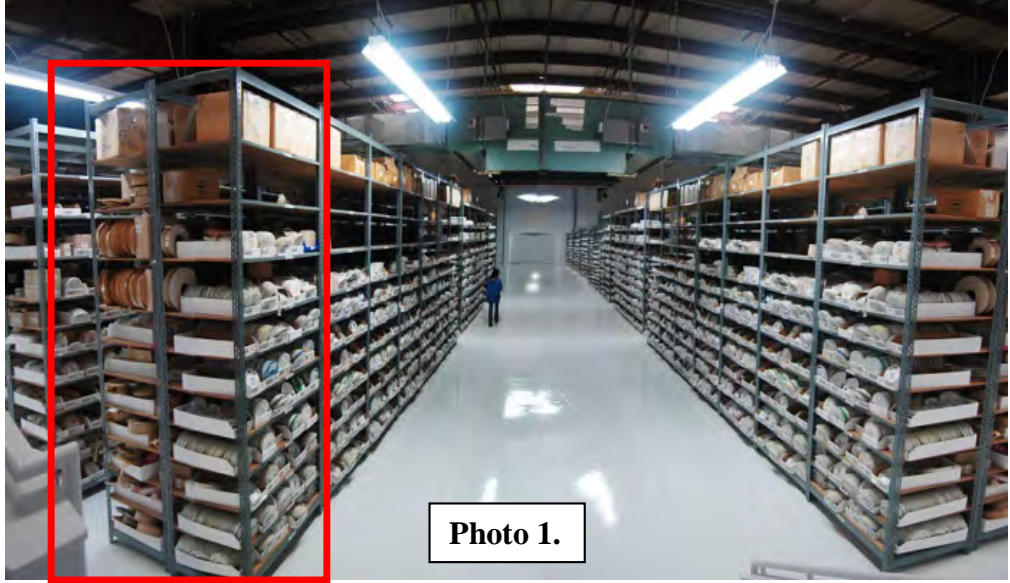
**Photo 1.**

Photo 1 metadata shows that it was taken before the theft on December 20, 2013 at 11:51 AM. It is then notable that there are empty shelves at various pre-theft inventory locations, and the criteria delineating empty shelves prior to the theft from those allegedly created by the theft have not been identified by A-Board. The Photo 1 empty shelves are primarily in the upper rack areas in a similar manner to the post-theft photos I took on May 16th. While Mr. Hone stated that the upper shelves were safer and where high-value product was stored, the lower shelf population preference could be to minimize the need for equipment such as ladders, and was observed to be consistent throughout the warehouse. The metadata for Photo 1 is shown below in Figure 1.

The mirror image set of shelves on the right side of Photo 1 were an Adobe Photoshop manipulation and do not exist in the warehouse. The double door at the rear of the photo was also largely obscured in Photoshop, and there may have been other minor touchups.

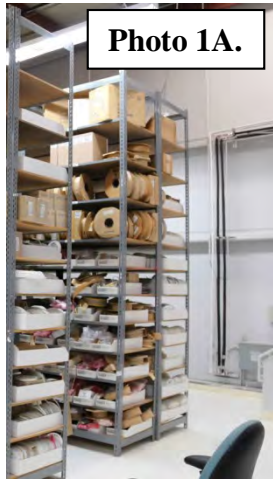
**Photo 1A.**

15. Photo 1A, above, is an excerpt of a post-theft picture I took during our May 16<sup>th</sup> A-Board meeting. Photo 1A was taken from a different perspective than Photo 1, but it can be seen by comparing Photo 1A to the red rectangle in Photo 1 that the inventory, location, type, shape, and orientation of shelved goods are the same, as is the empty shelf. While this is a small section of the warehouse, it is immediately adjacent to the reported theft point of entry and appears to have been untouched during the theft.

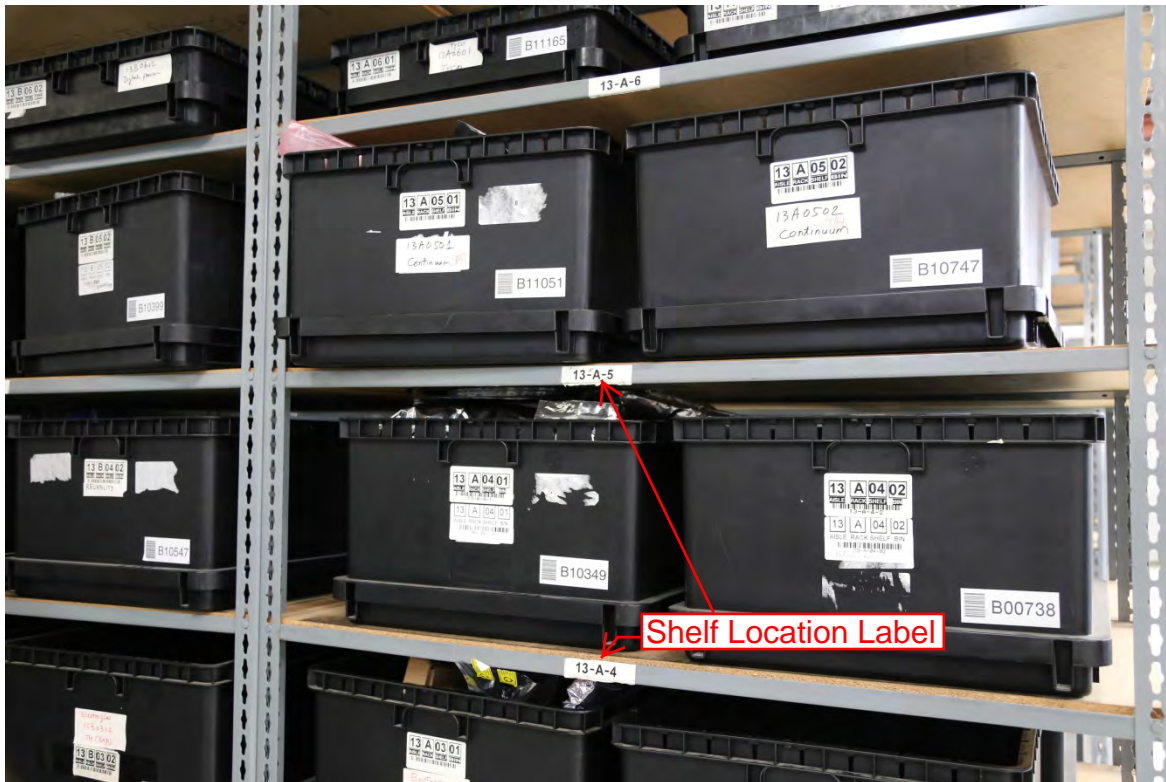
17. The R&K report also documents Mr. Hone's statement that up to \$20M in parts may have been stolen.
18. As can be seen in Photo 2 on Page 11, taken during my May 16<sup>th</sup> visit, all warehouse shelves have unique sequential identifiers as do most bins on the shelves:

19. During my May 16<sup>th</sup> visit, I asked Mr. Hone what the shelf labels (shown in Photo 2) were for. He confirmed that they were to identify item

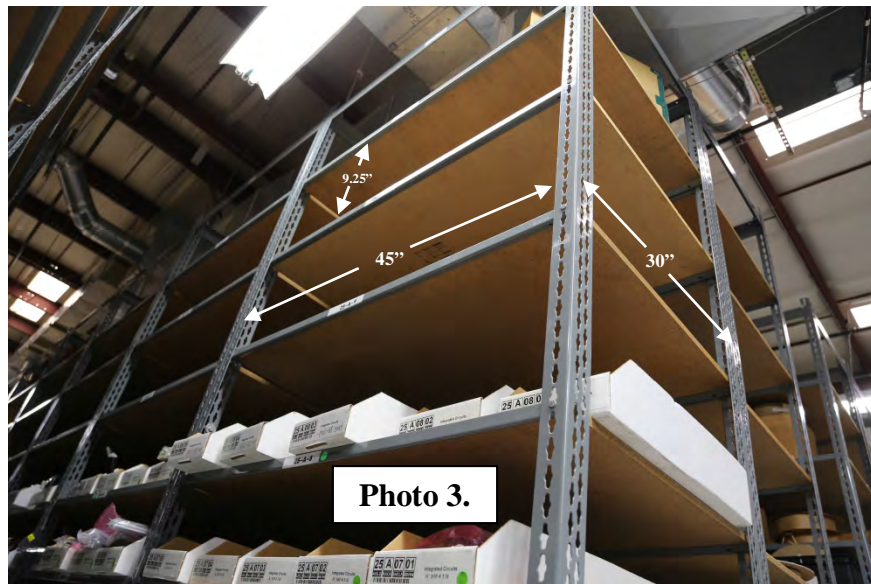
30. When we toured the warehouse, I asked Mr. Hone to show us the listed 82” Samsung LCD monitors. He told us they had been stolen during the break-in and pointed out the specific shelf locations where they had been. I looked up the shipping dimensions for a similar Samsung 82” monitor and found them to be 24” Deep X 59” High X 83” Wide with a weight of 340 pounds. With shelf dimensions at the specified locations that are 45” Wide x 9.25” High x 30” Deep on an aisle width of 29.5”, it does not seem to have been possible for the monitors to be stored on those shelves. I found more than 50,000 items in the pre-theft inventory with the designation “LCD Monitor”. LCD monitor is typically the description for

an LCD flat panel display. That many displays would have taken more empty shelf, floor space and volume than is currently available in the entire A-Board warehouse. Removal of that many large items would have also been challenging for what the Dallas Police Department called a white pickup truck used for the theft. Photo 3 below shows the 82” monitor shelves and their dimensions:

56. Since even one 82" LCD monitor listed in Warehouse 9 could not possibly fit on the shelves Mr. Hone identified as their pre-theft location, and the whole warehouse could not contain the thousands of LCD monitors and other equipment specified in the pre-theft inventory provided to Panterra Insurance, the pre-theft inventory is quite inaccurate. In fact, the "pre-theft" inventory, based on its metadata appears to have been generated approximately 2.5 weeks after the January 7, 2014 theft.

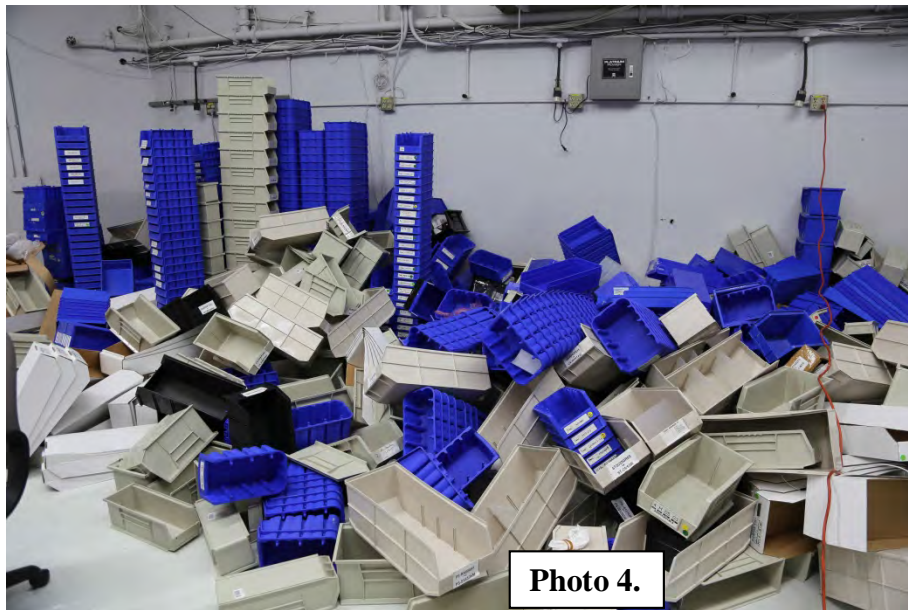
31. Photo 4 below shows a collection of empty containers piled on the floor in the front of the warehouse. Mr. Hone explained that the pile of containers was left by the thieves as they dumped components into larger bins to steal them. It is notable that the thieves took time to put the goods in larger bins and that they took the time to stack and nest some similar containers. Mr. Hone emphasized that the warehouse was on “lockdown” and that it was exactly how the thieves left it. He also stated that no empty containers were kept in the Photo 4 area prior to the theft. Later in the day Mr. Hone explained that since he had not conducted a post-theft physical

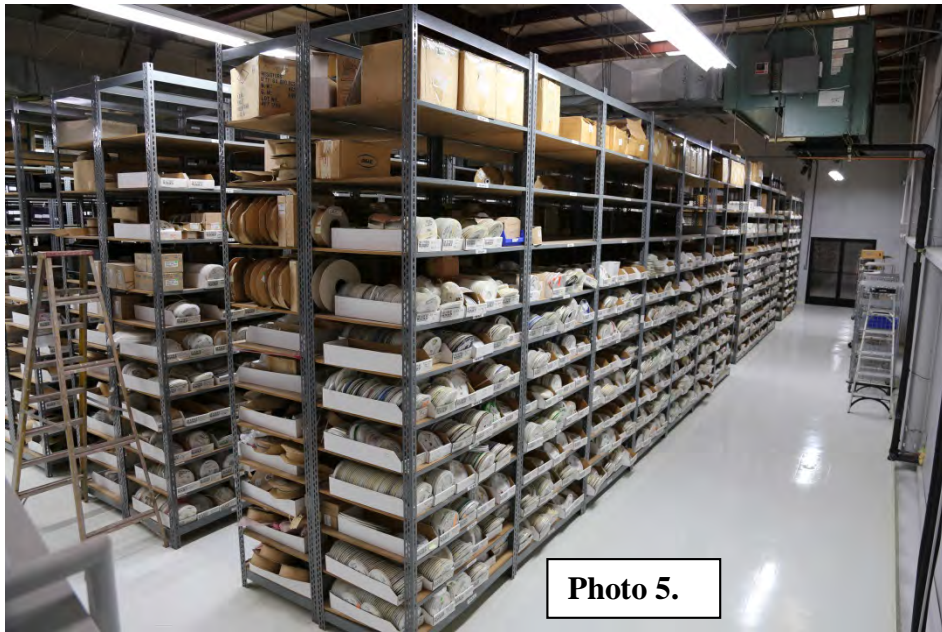
32. To augment Photo 1A, I photographed the shelves equivalent to the All Electrical web-site warehouse photo from a similar perspective during our A-Board physical inventory. That is shown in Photo 5 below:

33. If Photo 5 is compared to Photo 1, it can be seen that the post-theft inventory has not changed significantly and the empty shelves prior to the theft in Photo 1 remain empty in Photo 5 after the theft and populated shelves remain populated with what appear to be the same goods. Again, these warehouse racks are immediately adjacent to the reported point of entry used by the thieves. It also currently contains a new Asus LCD monitor. For ease of comparison, Photos 1 (right) and 5 (left) are shown side by side on the next page.

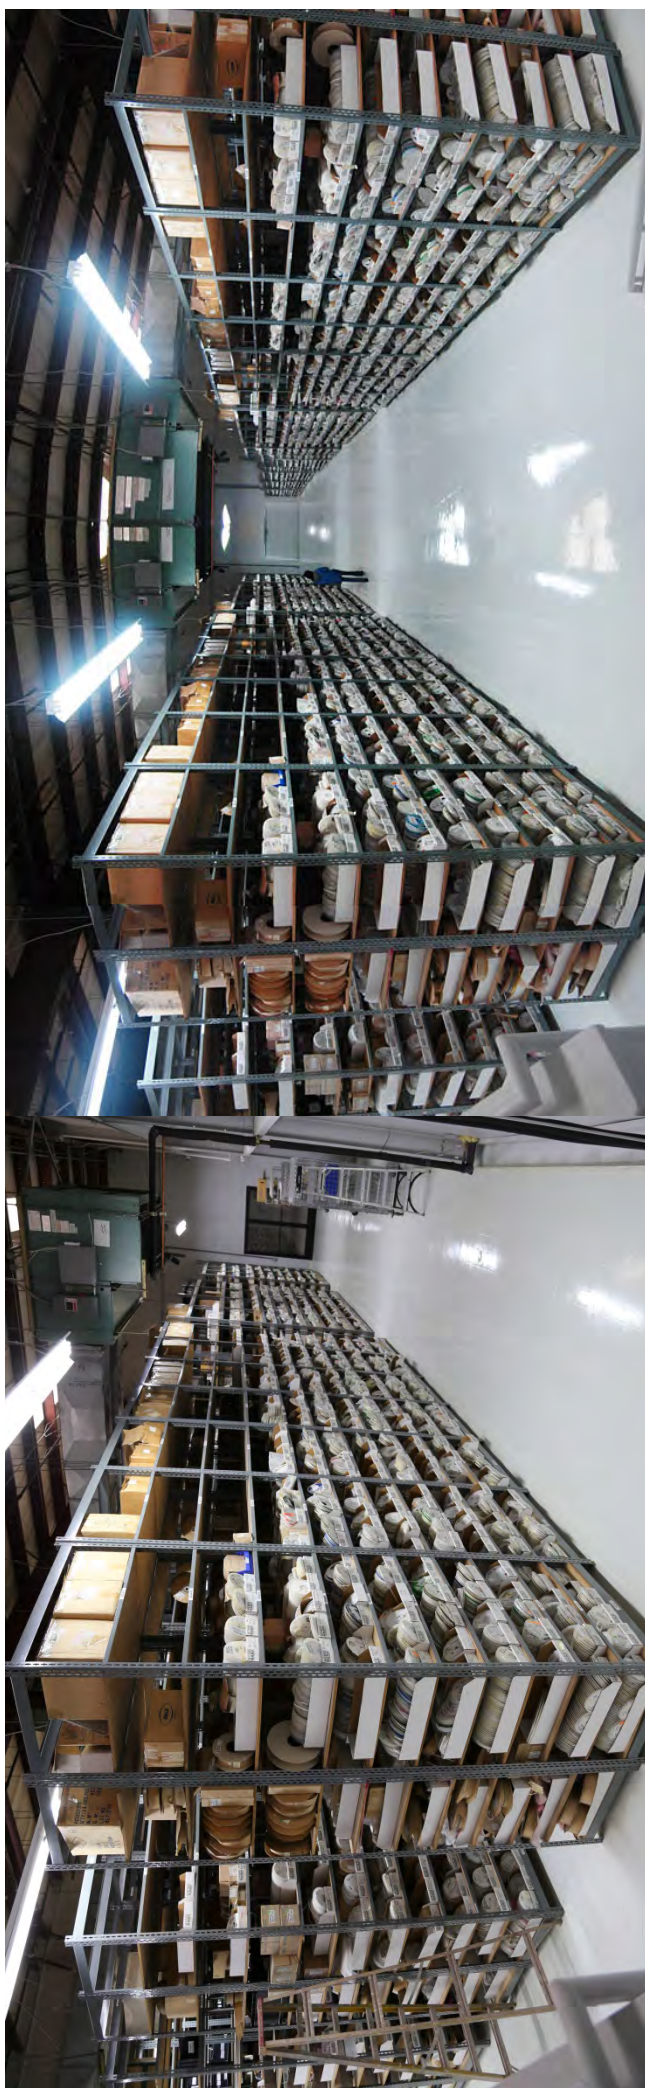
**May 25<sup>th</sup> 2014 Post-Theft Photo**

**December 20<sup>th</sup> 2013 Pre-Theft**

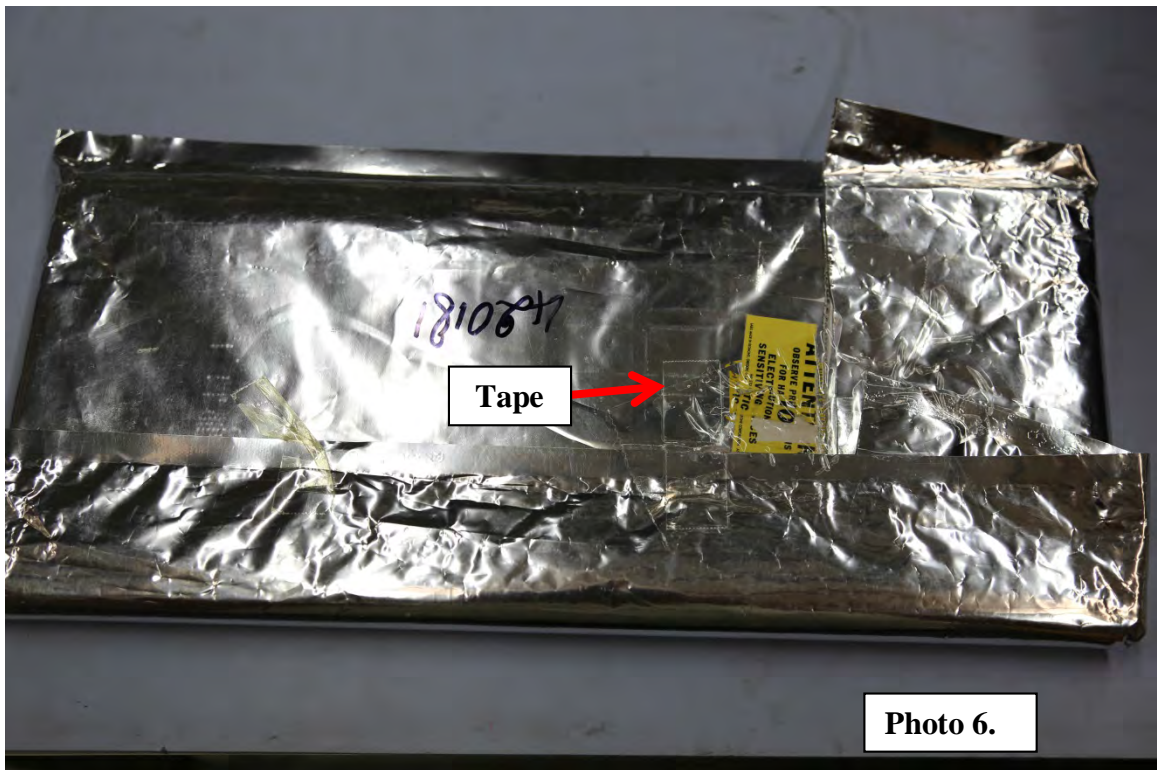
- a. As he stated at our May 16<sup>th</sup> meeting, Mr. Hone does not employ ESD dissipative tiles on the warehouse floor. The electronics industry uses ESD dissipative cardboard bins and other types of dissipative containers to store electronics. Most of the A-Board electronics storage bins were plain non-ESD rated cardboard. As exemplified in Photo 6 below, opened packaging had been resealed with standard office “Scotch Tape”.

*“Never use ordinary plastic adhesive tape near an ESD sensitive device or to close an anti-ESD bag. The act of pulling a piece of standard plastic adhesive tape, such as Scotch<sup>®</sup> tape, from its roll will generate a static charge of several thousand or even tens of thousands of volts on the tape itself and an associated field effect that can discharge through or be induced upon items up to a foot away.”*

From my own experience, I have found the use of Scotch Tape to be very destructive.

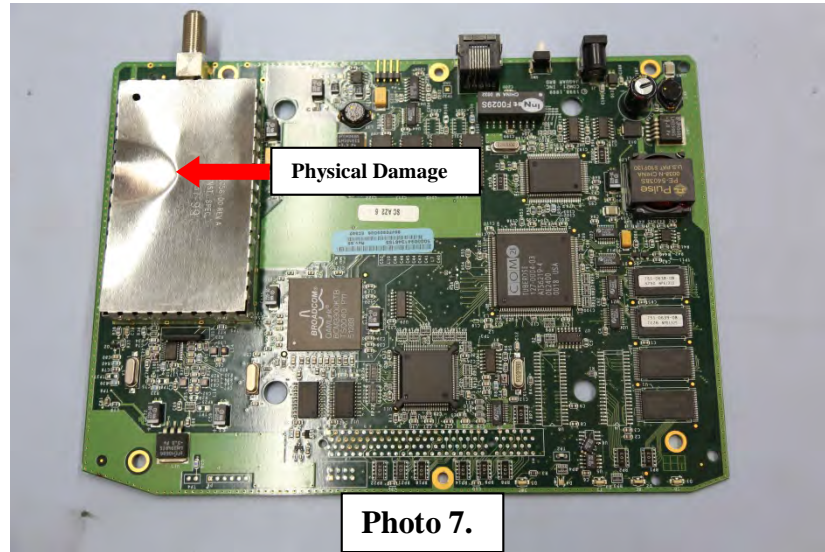
- g. Most printed circuit boards were unpackaged and piled on top of each other resulting in physical damage as is shown in Photo 7 below:

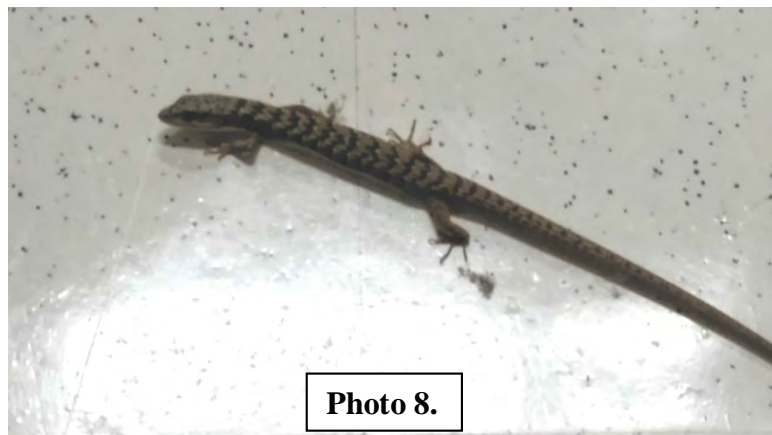
- h. R&K personnel complained about large spiders, some of which were in bins with electronics. I also took a picture of a large lizard on the warehouse floor adjacent to a rack of shelves containing electronics as shown below in Photo 8:

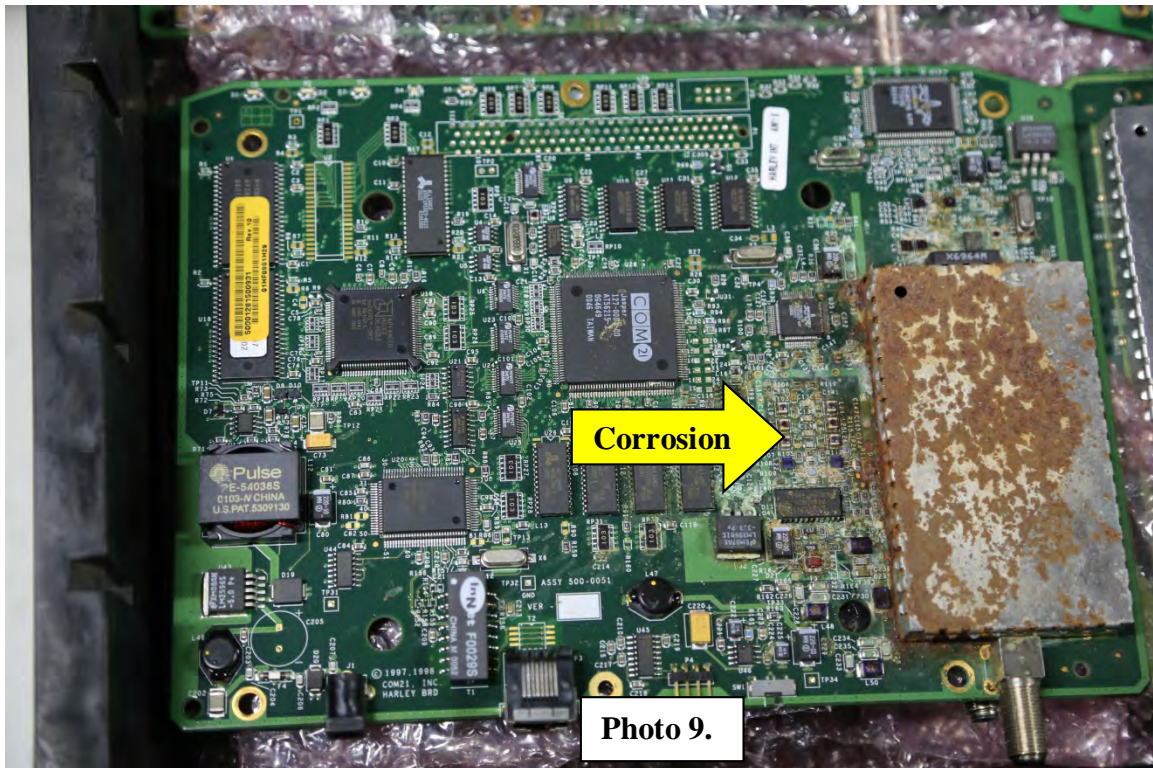
- i. Another example of PCB damage that could be related to animal infestation or other contaminants is shown in Photo 9 below:

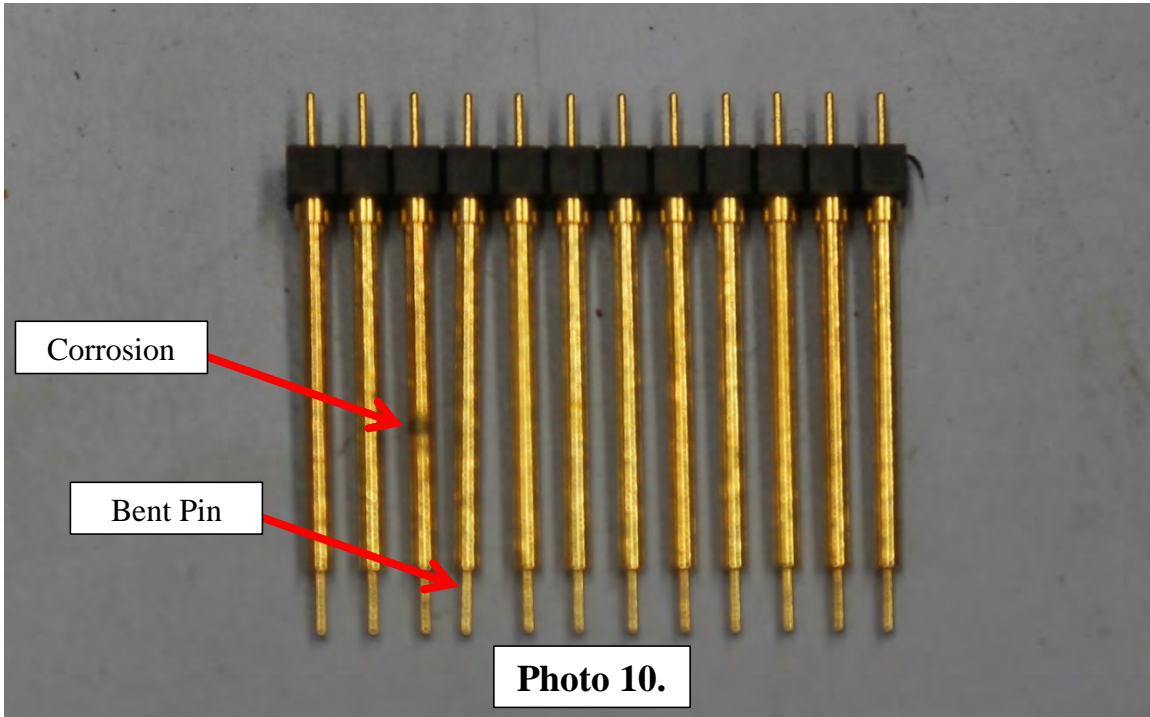
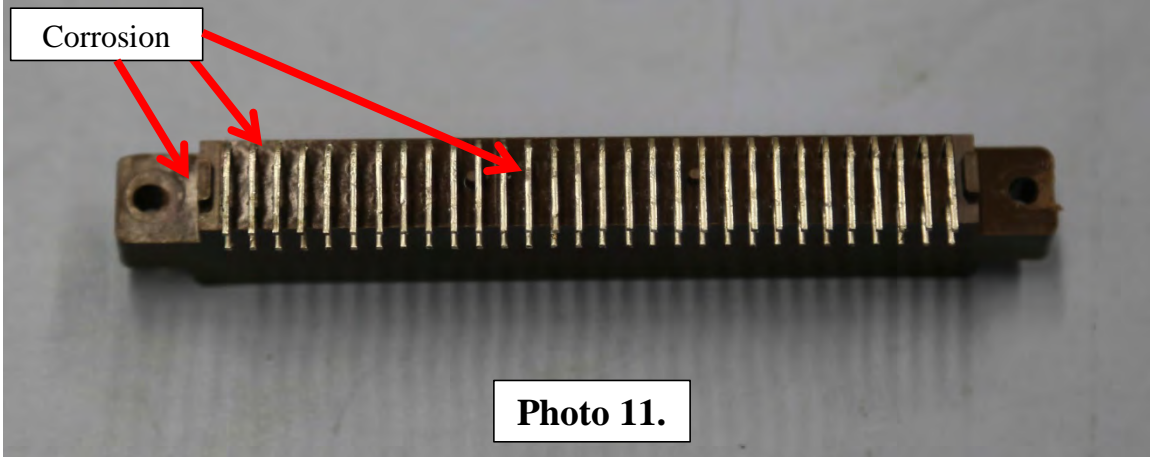
- j. Most racks of shelving had some empty upper shelves similar to those evident in pre-theft Photo 1.
- k. The shelves along the warehouse back wall (Rack 31) containing connectors and sockets were fully populated possibly indicating no component theft in that area. The Warehouse Layout diagram is shown on Page 33 of this report. Most connectors were beyond a seven year age and some had evidence of degradation as is shown in Photo 10 and 11 below.

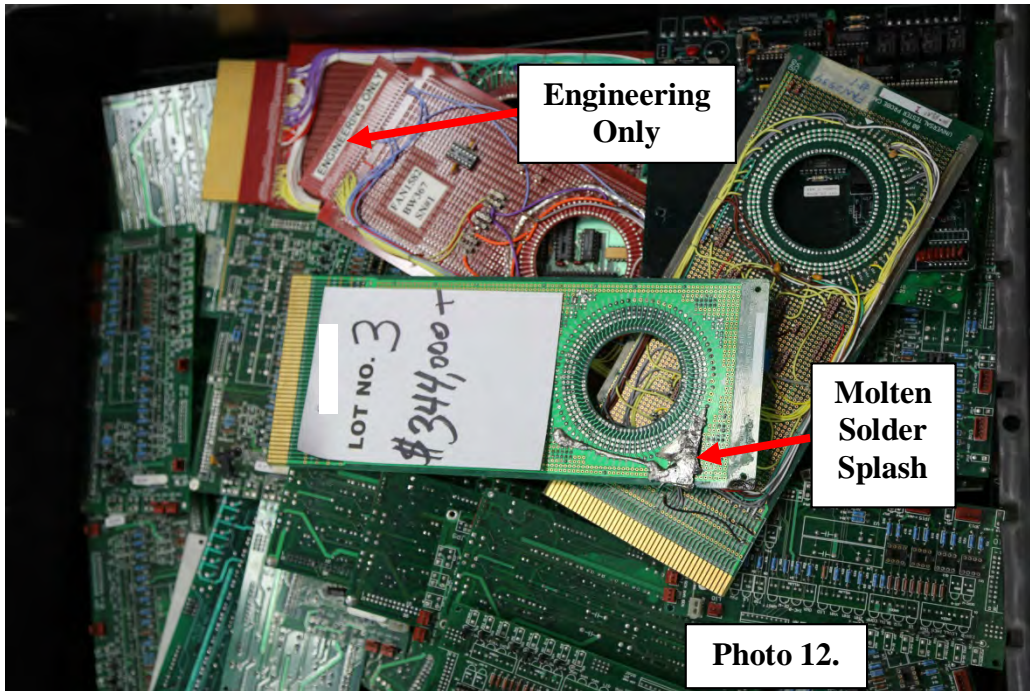
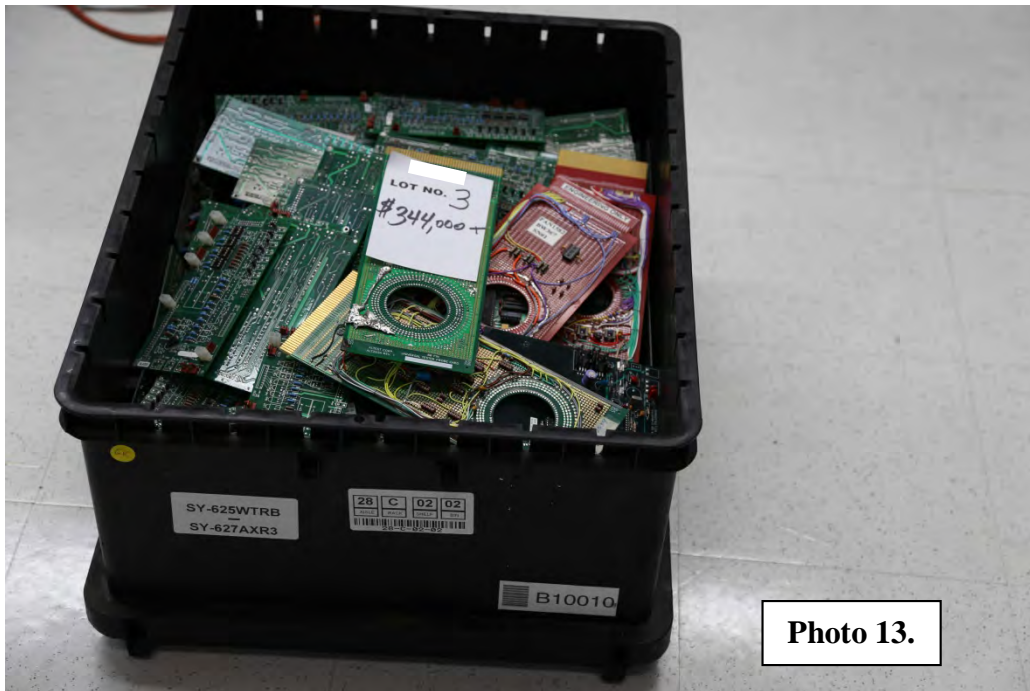
38. During their March 2014 visits, R&K had valued selected A-Board warehouse items. During the inventory, Sam Brandis showed me some of the items he had established the values on. An example of PCBs in a bin is shown below in Photos 12 and 13:

39. As can be seen from the R&K label, the bin of PCBs was valued at over \$344,000.00. Sam Brandis explained that the valuation was largely based on what Mr. Hone told him with regard to value.

40. The PCBs with circular cutouts are “probe cards” used to test semiconductor devices in wafer form. As can be seen, they are hand wired and likely for very specific devices and types of tests. The “Engineering Only” designation indicates the probe cards are for engineering analysis of some type and are likely not for resale as a commercial product. After tiny needle-like probes are attached to the probe cards, they can be used for testing replicated individual semiconductors with specific geometry on a wafer. A semiconductor wafer example is shown in Photo 14 below:

41. In comparing the bin of PCBs shown in Photos 12 and 13 to industry standard requirements outlined in the Preface of this report, I found the following:

- a. The boards are stacked on top of each other without packaging
- b. There are essentially no ESD measures employed
- c. The boards are not protected from moisture by a moisture barrier bag or desiccant

- d. There are no date codes on the boards I examined, so the age of the boards cannot be discerned.
- e. A label on the bin indicates it contains 41 part types, “SY-625WTRB” through SY627AXR3”. On the pre-theft inventory those appear to be Supermicro Barebone Servers. The probe cards described above are not listed in the SY-625WTRB through SY627AXR3 sequence of part numbers, and I saw nothing that looked like a bare bones server. Sam and Karla Brandis told me with certainty that Mr. Hone had told them several times that the bin labels containing a part number, a dash, and then a second part number, as discussed above, indicated the applicable sequence of product on the pre-theft inventory spreadsheet. I asked Mr. Hone to confirm that during the inventory and he said sometimes that is the case and sometimes it is not.

50. Mr. Hone said that he has been in business for 18 years. Since the vast majority of warehouse electronic components are opened in partially used packages, they are likely overages from PC Boards produced over the 18 years. The date code ranges are also somewhat consistent with that time period. The printed circuit boards, exemplified in Photo 12 are also, in part, likely to be production overages.

51. Inventory such as that shown in Photo 12 is scrap material whose value is not more than can be obtained via metal recovery. The latter is miniscule relative to the intended product sale price, or the \$344,000 valuation.

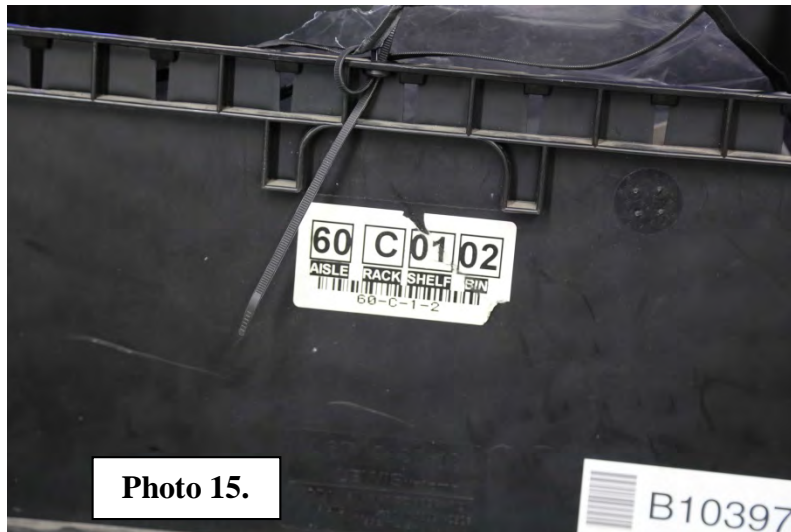
**Photo 15.**

42. Mr. Hone had previously stated that no empty bins had been at the Photo 3 location until the thieves put them there during the robbery. During the inventory, I noticed the bin shown in Photo 15 below:

43. Joan Sands was assigned as our support point of contact during the inventory by Mr. Hone. Since I could not find aisle 60, in the warehouse, I asked Ms. Sands where aisle 60 was located at A-Board. She left, came back and said Mr. Hone stated "it was just a number on a box and did not mean anything". Since Mr. Hone had stated that no electronics inventory was stolen from anywhere but the warehouse and aisle 60 appears to be a location external to the warehouse, it is unlikely the thieves placed that bin in the Photo 3 area.

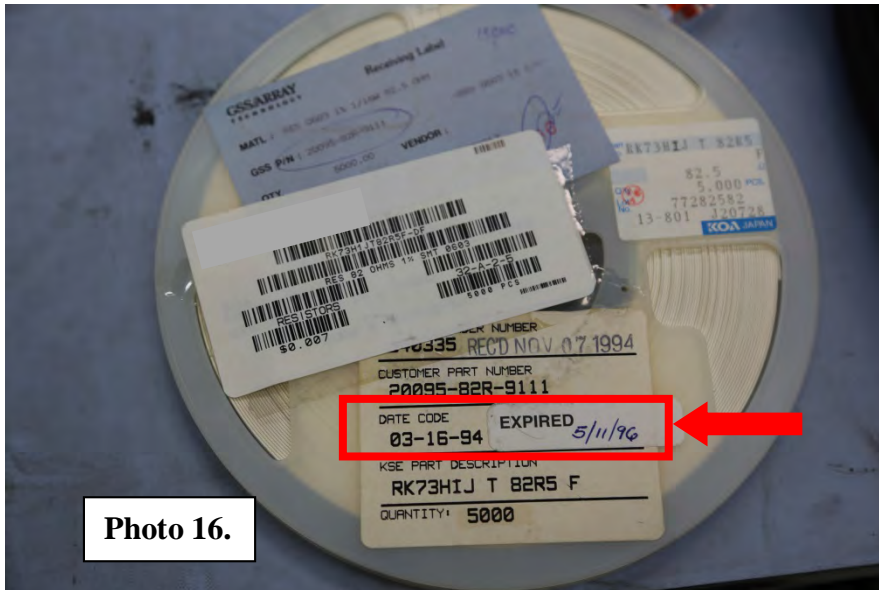
Photo 16.

45. Many of the surface mount device (SMD) reels had date codes as old as 1983, were completely unpackaged, dirty, and frequently had components on the tape dangling off the shelf. More than half the reels had no date code at all, and many original labels had been obscured and covered by All Electrical labels. Photo 16, 17, and 18 below exemplify some of those findings:
